**Messerschmidt  
Safety Consultants**

The following summarizes our chip-level digital forensics into the damaged Sensing and Diagnostic Module (SDM) from a 2004 GMC Yukon VIN 1GKEC13Z04R289898.

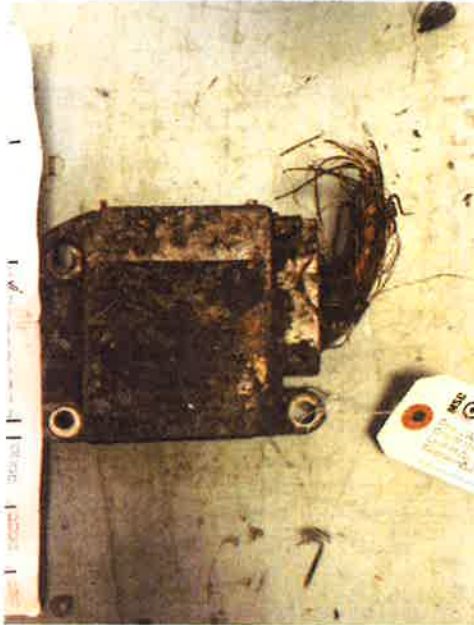
**Figure 1: Subject SDM**

Upon receiving the SDM, it was photographed and entered into our evidence intake system. The subject SDM was evaluated to determine the extent of damage. The outside case showed signs of extreme heat exposure. The Input/Output connectors and corresponding wiring harness was visibly melted, this made any attempts to back probe the connector impossible (Figure 2). Upon inspecting the underside of the module the sealant used to protect the printed circuit board (PCB) was visibly charred and appeared to have undergone chemical decomposition as a result of the heat (Figure 3). A corner section of sealant was scrapped away to evaluate any PCB damage due to heat (Figure 4). A visible inspection of the PCB determined the board began to delaminate due to extreme temperatures. At this time, it was determined the board could not be repaired.
